Thilawa Special Economic  
Zone (Zone B) Development

## Environmental Monitoring Report Phase-3 and 4 (Construction Phase)

Myanmar Japan Thilawa  
Development Limited.

June 2020

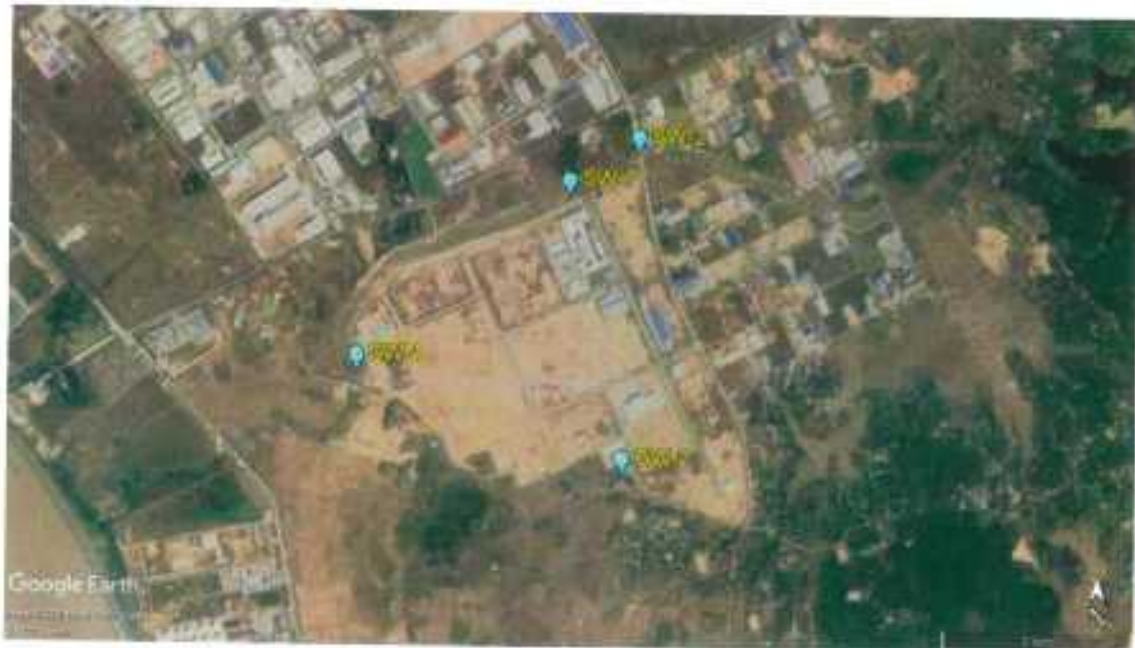
Figure 1.1-1 Location of Sampling Points of Water Quality Monitoring

Thilawa Special Economic Zone (SEZ) is located in southern district of Yangon region and about 23 km southeast of Yangon city. As the developer of Thilawa SEZ, Myanmar Japan Thilawa Development Ltd. (MJTD) has a responsibility to carry out regular monitoring in the industrial area of Zone B in accordance with the approved Environmental Impact Assessment (EIA) report and Environmental Management Plan (EMP). MJTD has implemented monitoring various environmental items with the specified time frame to know the environmental conditions in and around the area. As for the monitoring of the water quality, total four sampling points are set for water quality survey, named SW-2, SW-4, SW-7, and GW-2 have been monitored in Thilawa SEZ and its surrounding area in timely manner. Among the four locations, SW-7 is main discharged point of Zone B during the construction stage. Moreover, GW-2 is monitored as a reference of existing tube well which located in the monastery compound of Phalan village. Location of sampling points for water quality monitoring is shown in Figure 1.1-1.

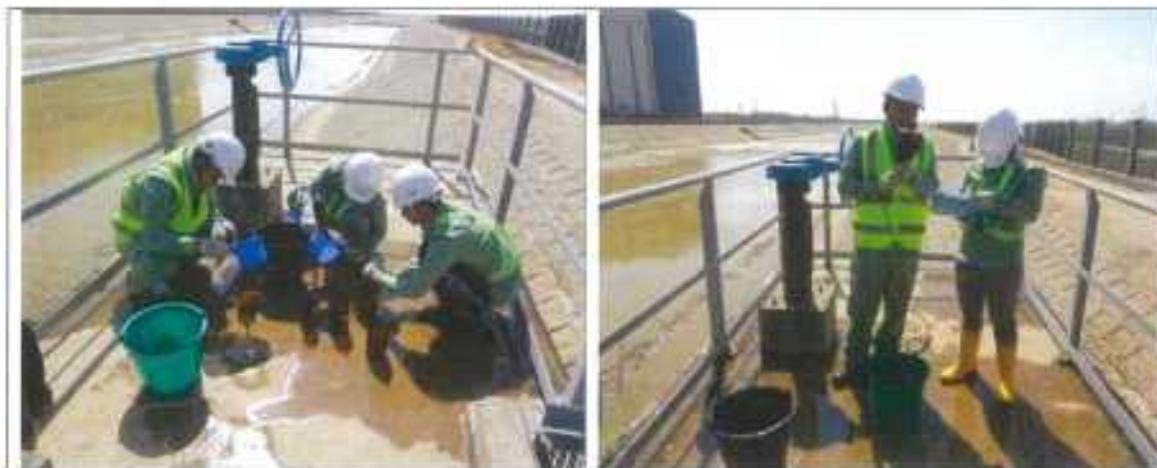
As for the result of SS and TDS results at the surface water monitoring points (SW-4 and SW-7) exceeded the target value. As for the result of TDS, results at the surface water monitoring points (SW-4 and SW-7) exceeded the target value. The exceed results for SS and TDS maybe due to three expected reasons; i) soil erosion caused by construction of factories in Zone B and eroded soil particles may contain soluble compounds that can dissolve in water, ii) delivered from upstream area such as natural origin and wastewater from local industrial zone outside of Thilawa SEZ, and iii) influence by water from the downstream due to flow back by tidal fluctuation.

Surface water sampling and onsite measurement at SW-7

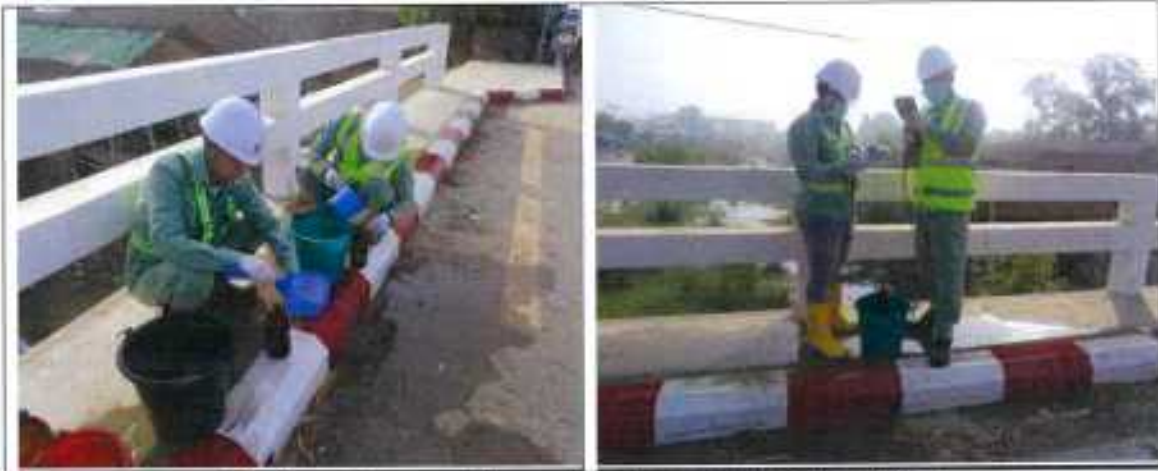
Surface water sampling and onsite measurement at SW-2

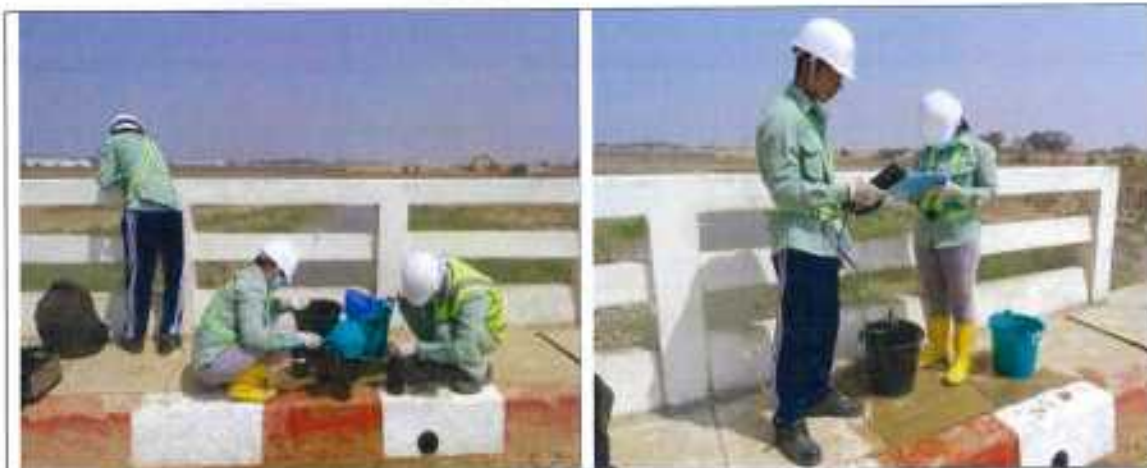
Surface water sampling and onsite measurement at SW-4

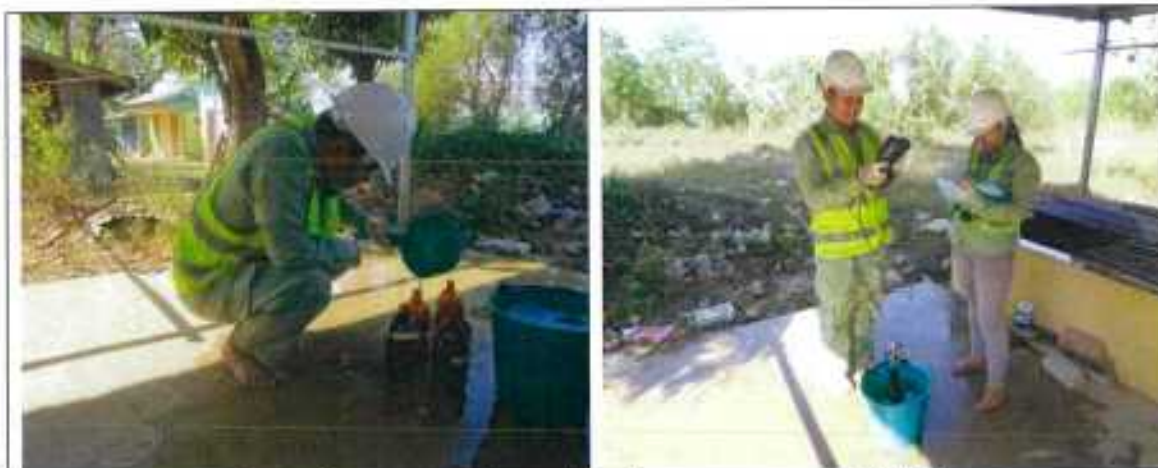
As for the result of the iron, the result at the monitoring point of reference tube well (GW-2) exceeded the target value. It may be due to the corrosion of pipes because the water is pumped through the iron pipelines buried underneath the ground. However, since it cannot reach to the conclusion of what is the reason for this result, the periodic monitoring will be necessary.

Ground water sampling and onsite measurement at GW-2

As for the result of the iron, the result at the monitoring point of reference tube well (GW-2) exceeded the target value due to expected reason. It may be due to the corrosion of pipes because the water is pumped through the iron pipelines buried underneath the ground. However, since it cannot reach to the conclusion of what is the reason for this result, the periodic monitoring will be necessary.

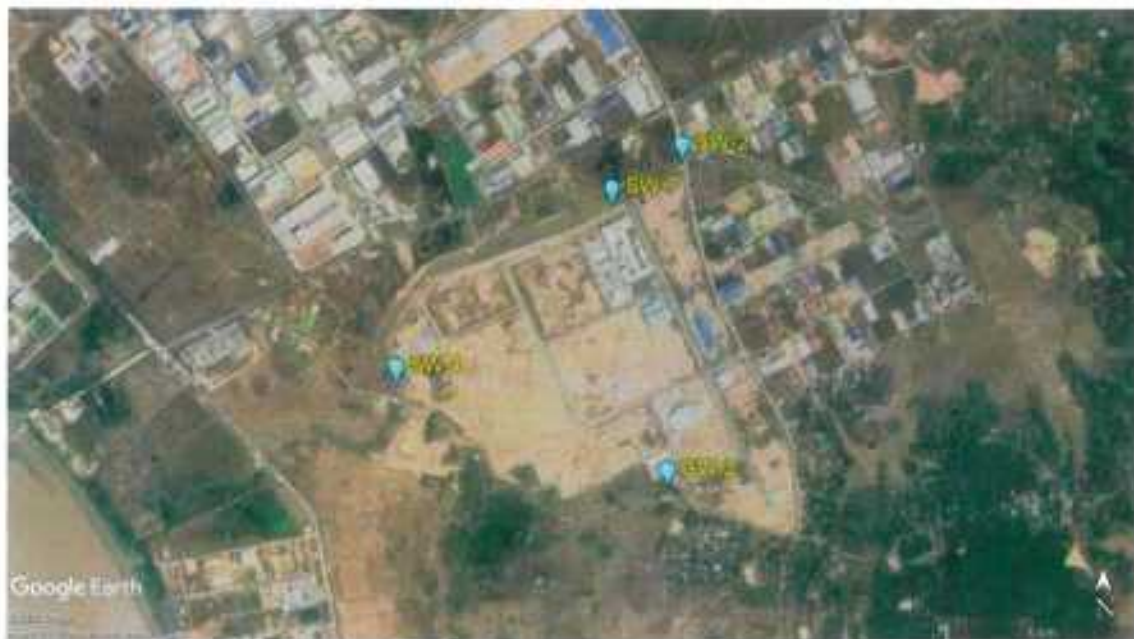
Figure 1.1-1 Location of Sampling Points of Water Quality Monitoring

Thilawa Special Economic Zone (SEZ) is located in southern district of Yangon region and about 23 km southeast of Yangon city. As the developer of Thilawa SEZ, Myanmar Japan Thilawa Development Ltd. (MJTD) has a responsibility to carry out regular monitoring in the industrial area of Zone B in accordance with the approved Environmental Impact Assessment (EIA) report and Environmental Management Plan (EMP). MJTD has implemented monitoring various environmental items with the specified time frame to know the environmental conditions in and around the area. As for the monitoring of the water quality, total four sampling points are set for water quality survey, named SW-2, SW-4, SW-7 and GW-2 have been monitored in Thilawa SEZ and its surrounding area in timely manner. Among the four locations, SW-7 is main discharged point of Zone B during the construction stage. Moreover, GW-2 is monitored as a reference of existing tube well which located in the monastery compound of Phalan village. Location of sampling points for water quality monitoring is shown in Figure 1.1-1.

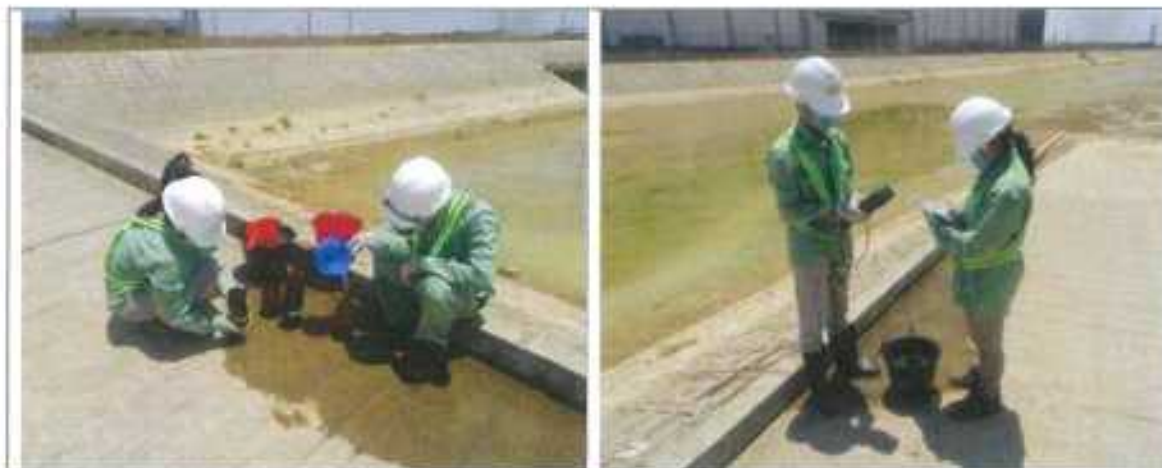
As for the result of SS, results at the surface water monitoring points (SW-2, SW-4 and SW-7) exceeded the target value. As for the result of TDS, results at the surface water monitoring point (SW-7) exceeded the target value. The exceed results for SS and TDS maybe due to three expected reasons; i) soil erosion caused by construction of factories in Zone B and eroded soil particles may contain soluble compounds that can dissolve in water, ii) delivered from upstream area such as natural origin and wastewater from local industrial zone outside of Thilawa SEZ, and iii) influence by water from the downstream due to flow back by tidal fluctuation.

Surface water sampling and onsite measurement at SW-7

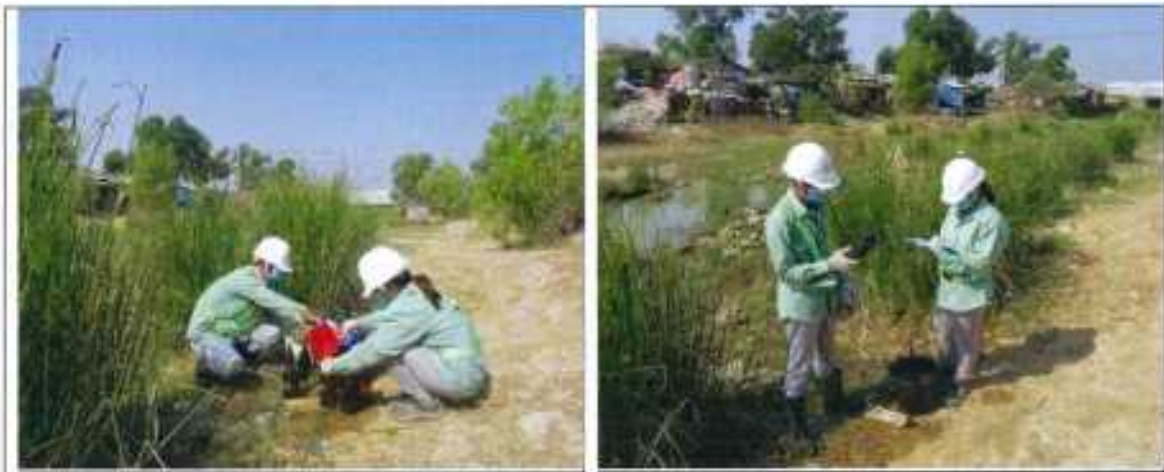
Surface water sampling and onsite measurement at SW-2

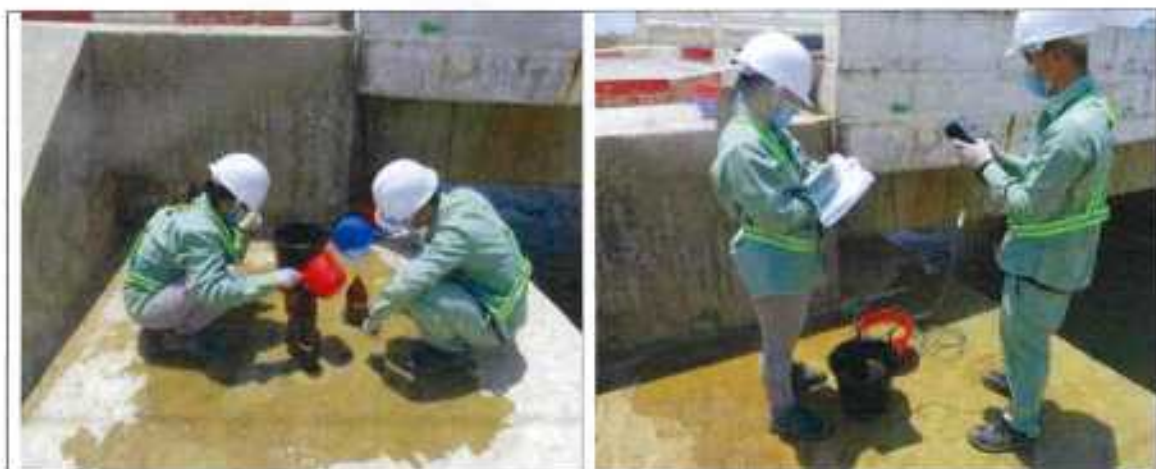
Surface water sampling and onsite measurement at SW-4

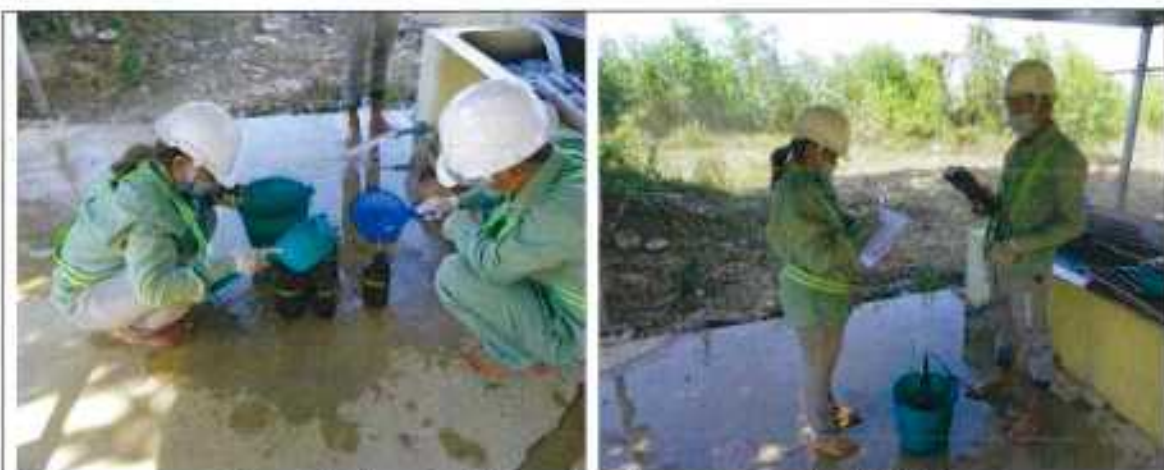
As for the result of the iron, the result at the monitoring point of reference tube well (GW-2) exceeded the target value. It may be due to the corrosion of pipes because the water is pumped through the iron pipelines buried underneath the ground.

Ground water sampling and onsite measurement at GW-2

As for the result of the iron, the result at the monitoring point of reference tube well (GW-2) exceeded the target value due to expected reason. It may be due to the corrosion of pipes because the water is pumped through the iron pipelines buried underneath the ground.

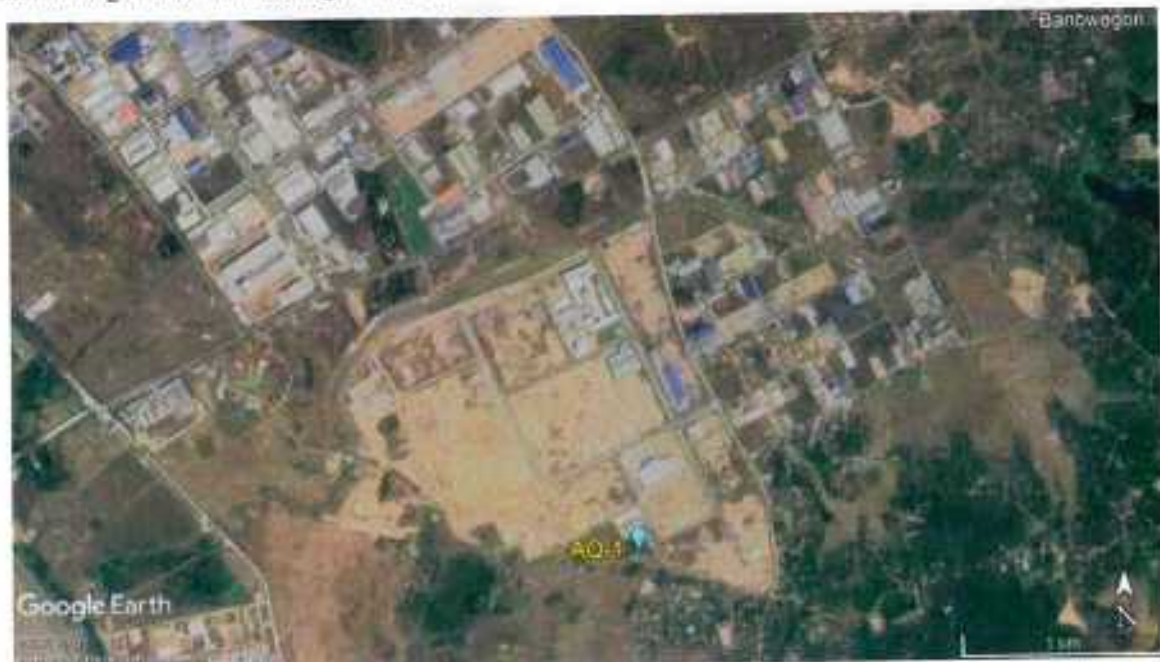
Figure 2.2-1 Location of Air Quality Monitoring Point

The air quality measurement equipment, "Haz-Scanner Environmental Perimeter Air Station (EPAS)" was set up at the south of the Thilawa SEZ Zone B, N: 16°39'24.20", E: 96°17'15.80", inside the monastery compound of Phalan village, surrounded by the residential houses of Phalan village in the south and fields in west, Thilawa SEZ Zone A in north, local Thilawa Industrial Zone in northeast and construction of Thilawa SEZ Zone B in east, north, north-northwest, northwest and northeast respectively. The air quality monitoring is carried out above location where is near to the residential houses of Phalan village. Possible emission sources are dust emissions from construction activities and exhaust gas emissions from construction fuel-burning equipment and daily human activities in Phalan village. The location of air quality monitoring is shown in the Figure 2.2-1.

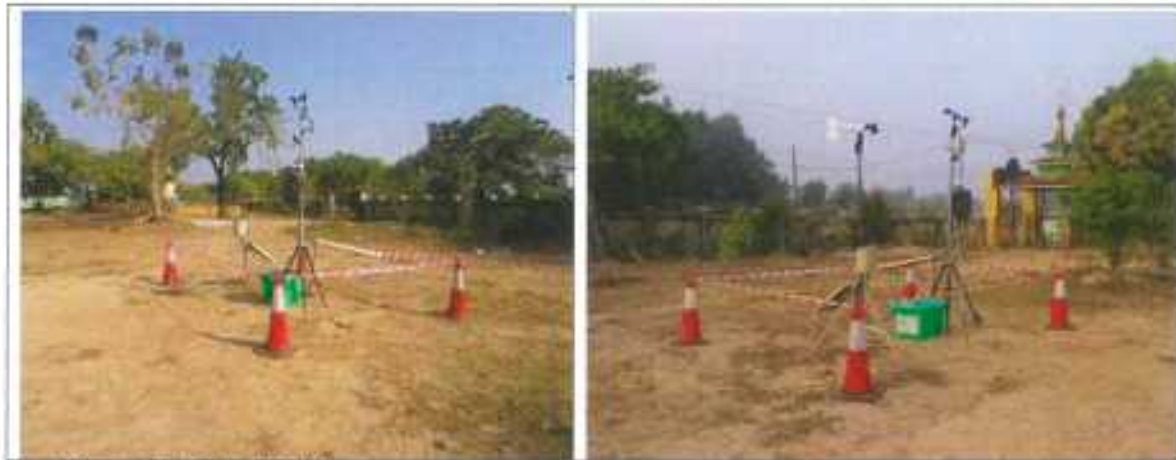
Monitoring of CO, NO<sub>2</sub>, PM<sub>2.5</sub>, PM<sub>10</sub> and SO<sub>2</sub> were conducted by referring to the recommendation of the United States Environmental Protection Agency (U.S. EPA). The Haz-Scanner EPAS was used to collect ambient air pollutants. The EPAS measures automatically every one minute and directly reads and records onsite for CO, NO<sub>2</sub>, PM<sub>2.5</sub>, PM<sub>10</sub> and SO<sub>2</sub>. The state of air quality monitoring is shown in Figure 2.4-1.

Figure 2.4-1 Status of Air Quality Monitoring Point

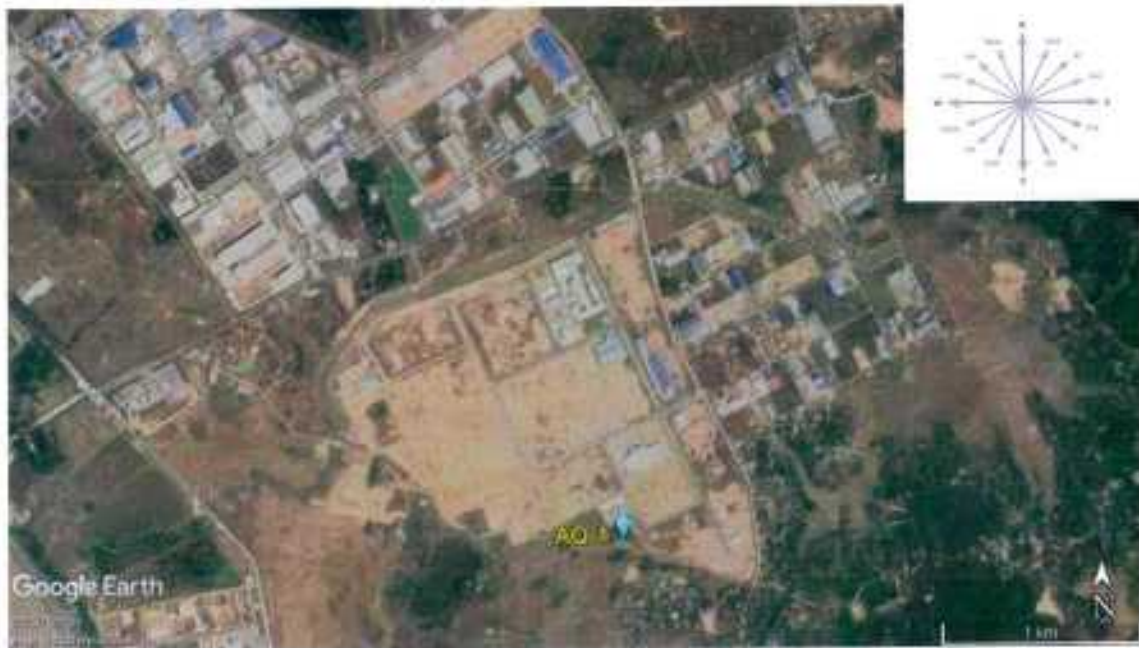
Wind direction and wind speed were measured at AQ-1. Hourly average values of measured wind direction and wind speed data are described in Appendix-1. Status of air quality monitoring point and wind direction are described in Figure 2.5-1. Depending on the wind direction, West-Northwest (WNW), Northwest (NW), North-Northwest (NNW), North (N), North-Northeast (NNE), Northeast (NE), East-Northeast (ENE) and East (E) directions are assumed to come from the construction site of Zone B.

**Figure 2.5-1 Status of Air Quality Monitoring Point and Wind Direction**

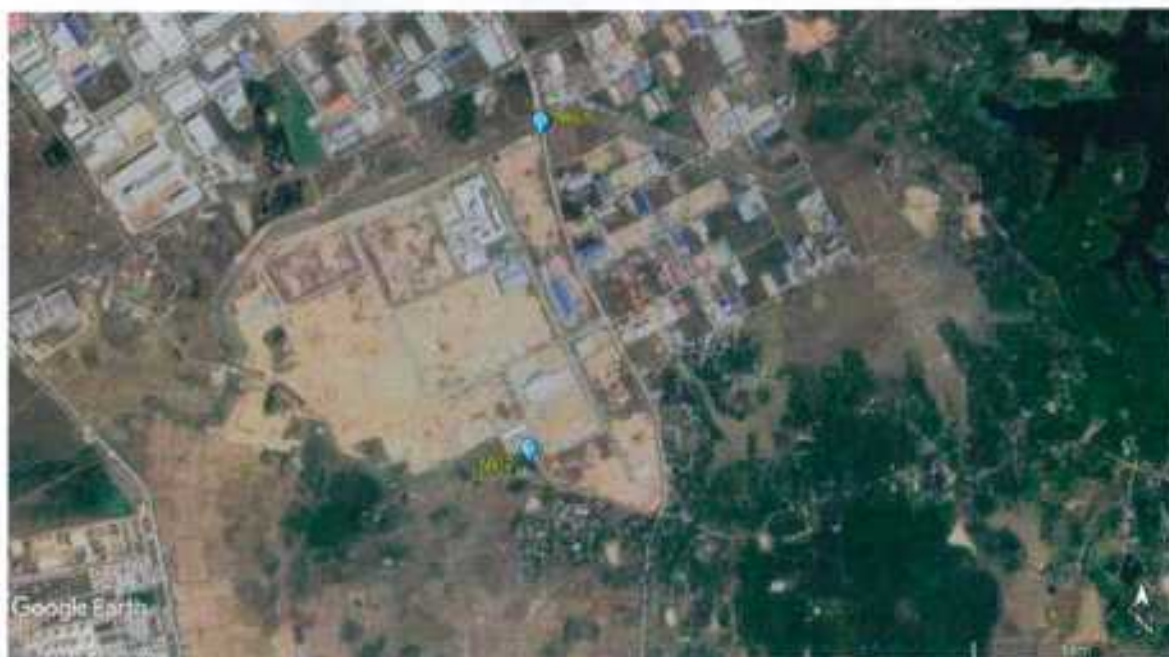
**Figure 2.2-1 Location of Noise and Vibration Level Monitoring Points**

Noise and vibration levels were measured in the northeast corner of the Thilawa SEZ Zone B, monitoring point (NV-1); N: 16°40'18.22", E: 96°17'18.18" for traffic noise concerned and in the south of the Thilawa SEZ Zone B, monitoring point (NV-2); N: 16°39'24.90", E: 96°17'16.70", inside the monastery compound of Phalan village. The location of the noise and vibration monitoring points are shown in Figure 2.2-1.

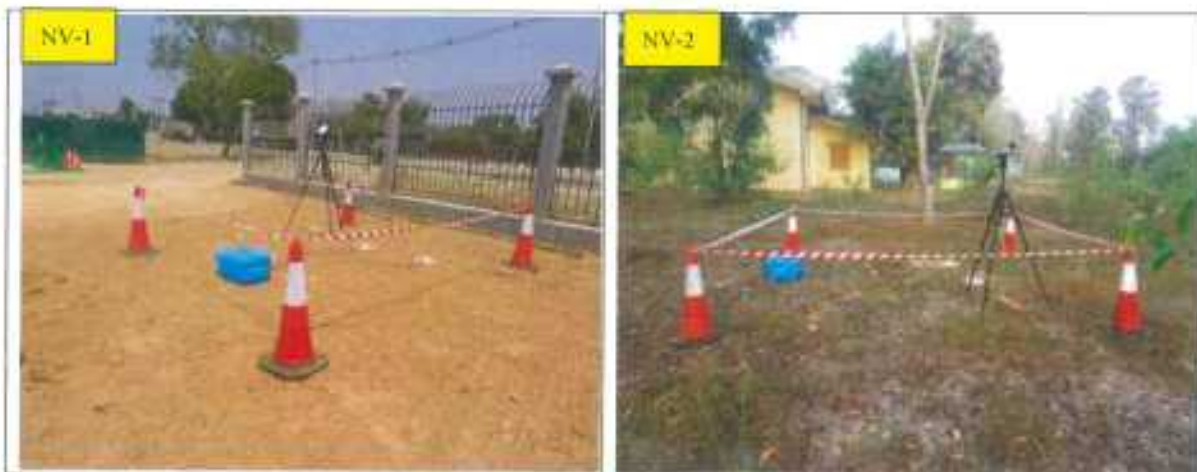
Noise level was measured by "Rion NL-42 sound level meter" and automatically records every 10 minutes in a memory card. The vibration level meter, VM-53A (Rion Co., Ltd., Japan), was accompanied by a 3-axis accelerometer PV-83C (Rion Co., Ltd.) and it was placed on solid soil ground. Vertical vibration (Z axis),  $L_v$ , was measured every 10 minutes within the adaptable range of (10-70) dB at NV-1 and (10-70) dB at NV-2 and recorded to a memory card.

The measurement period of noise and vibration was 24 hours for each monitoring point. The status of the noise and vibration level monitoring on NV-1 and NV-2 are shown in Figure 2.3-1.

**Figure 2.3-1 Status of Noise and Vibration Level Monitoring at NV-1 and NV-2**

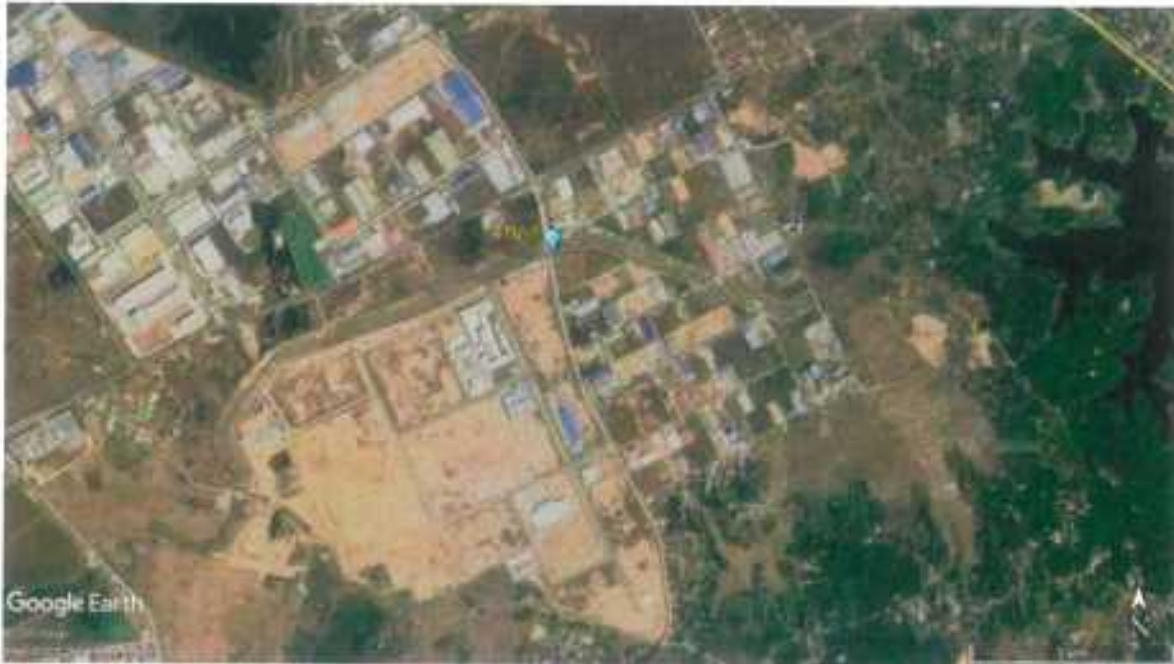
Figure 2.2-1 Location of Traffic Volume Monitoring Point

Traffic volume was measured at the northeast corner of the Thilawa SEZ Zone B, monitoring point (TV-1); N: 16°40'17.90", E: 96°17'18.20". The location of the traffic volume monitoring point is shown in Figure 2.2-1.

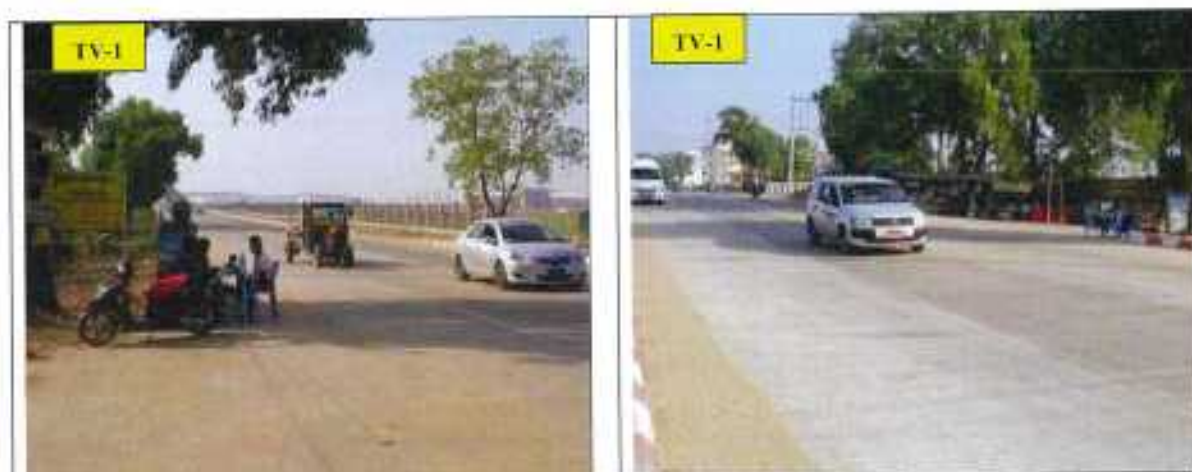
The traffic volume monitoring was conducted for 24 hours at the same time as the traffic noise and vibration level monitoring. Traffic volume monitoring was conducted to count the number of vehicles moving in each direction. Manual count method was used and data was recorded using tally sheets. The status of the traffic volume monitoring on TV-1 is shown in Figure 2.3-1.

Figure 2.3-1 Status of Traffic Volume Monitoring at TV-1

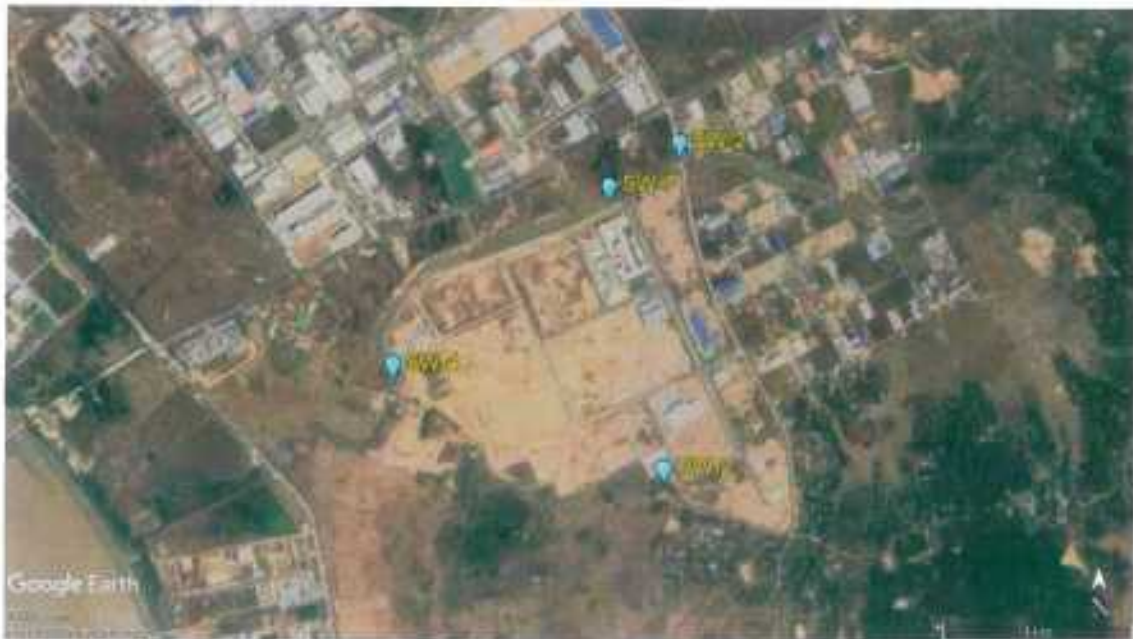
ပုံ ၁.၁-၁ ရေအရည်အသွေးစောင့်ကြည့်လေ့လာမှုအတွက်နမူနာရယူသောနေရာများ၏ တည်နေရာပြပုံ

ရေအရည်အသွေးစောင့်ကြည့်လေ့လာမှုအား စစ်တမ်းကောက်ယူရာတွင် သီလဝါအထူးစီးပွားရေးဇုန်အတွင်းနှင့် အနီးပတ်ဝန်းကျင်ရှိ စုစုပေါင်းနေရာ လေးနေရာ၊ နာမည်အားဖြင့် မြေပေါ်ရေနေရာယူသည့် နေရာ-၂ (SW-2)၊ မြေပေါ်ရေနေရာယူသည့် နေရာ-၄ (SW-4)၊ မြေပေါ်ရေနေရာယူသည့် နေရာ-၇ (SW-7) နှင့် မြေအောက်ရေနေရာယူသည့် နေရာ-၂ (GW-2) တို့တွင် စောင့်ကြည့်လေ့လာခဲ့ပါသည်။ ထိုနေရာ လေးနေရာမှ မြေပေါ်ရေနေရာယူသည့် နေရာ-၇ (SW-7) သည် ဇုန်အပိုင်း(ခ) ဆောက်လုပ်ရေးကာလတွင် အဓိကစွန့်ထုတ်ရေထွက်ပေါက် ဖြစ်ပါသည်။ ထို့အပြင် မြေအောက်ရေနေရာယူသည့် နေရာ-၂ (GW-2) အား ဖလမ်းကျေးရွာတွင်တည်ရှိသော ဘုန်းကြီးကျောင်းပရဝဏ်အတွင်းရှိ ရေတွင်းအား ရည်ညွှန်းနိုင်ရန် စောင့်ကြည့်လေ့လာခဲ့သည်။ ရေအရည်အသွေးစောင့်ကြည့်လေ့လာမှုအတွက် နမူနာရယူသော နေရာများ၏ တည်နေရာများကို ပုံ ၁.၁-၁ တွင် ဖော်ပြထားပါသည်။

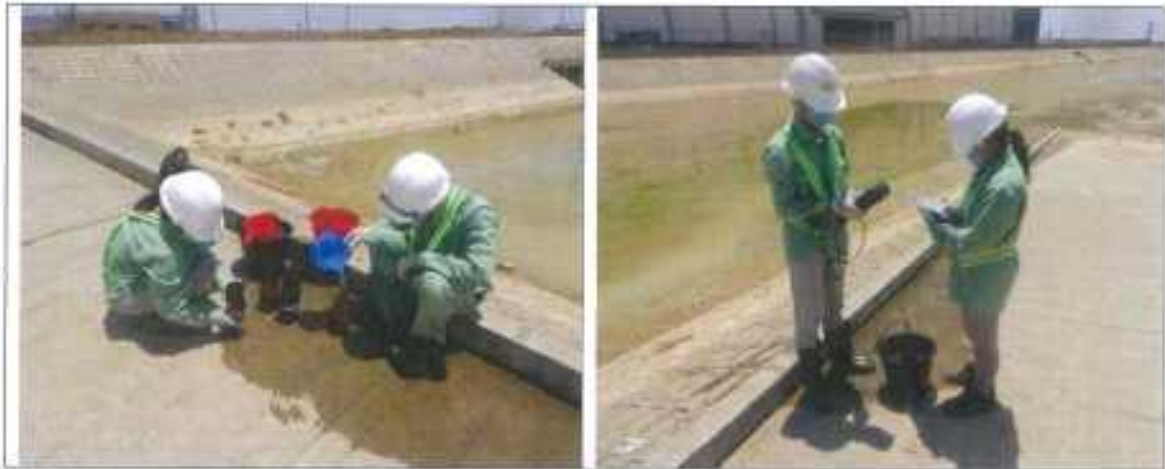
မြေပေါ်ရေကုန်သွယ်မှုနေရာ (SW-7) မှ ရေကုန်သွယ်ခြင်းနှင့်တိုင်းတာခြင်း

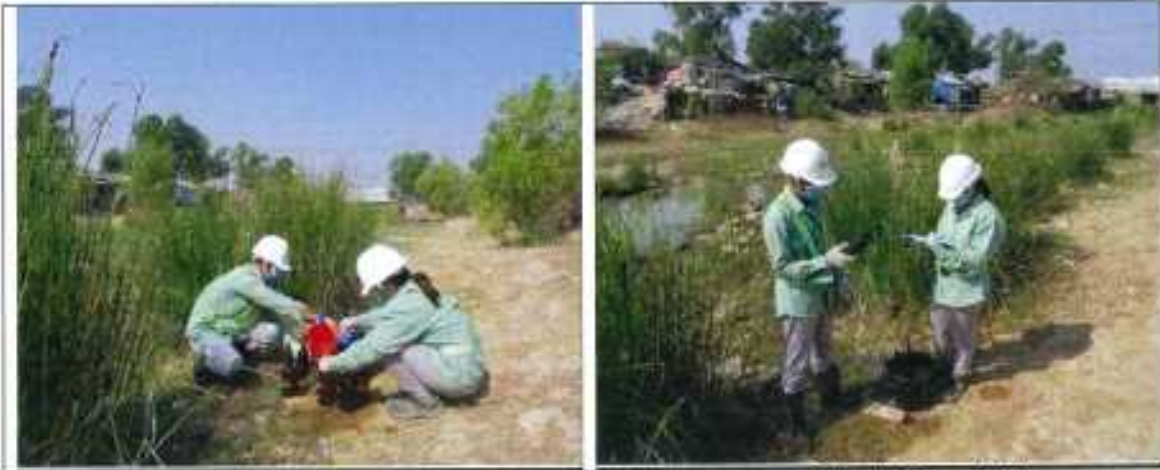
မြေပေါ်ရေနမူနာယူသည့် နေရာ-၂ (SW-2) ၌ ရေနမူနာရယူခြင်းနှင့်တိုင်းတာခြင်း

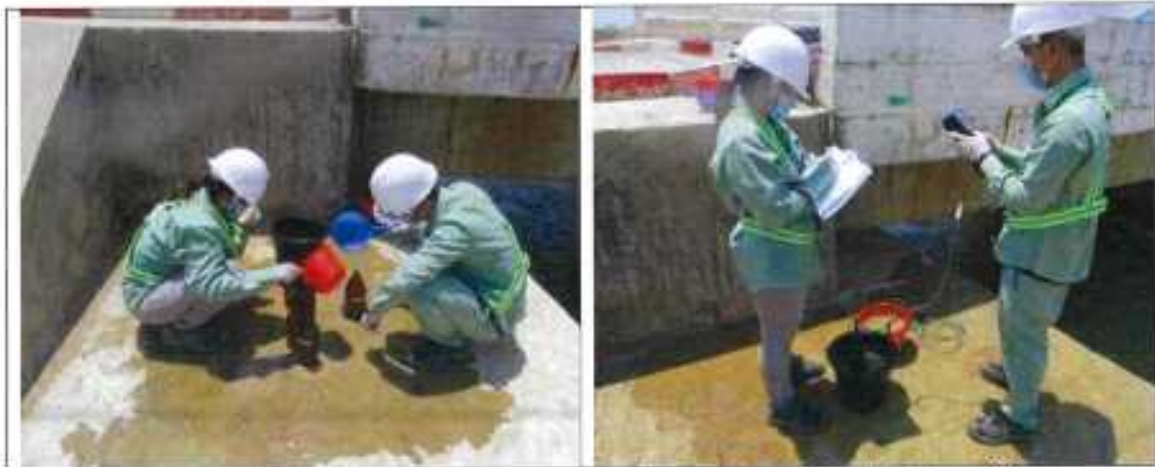
မြေပေါ်ရေနမူနာယူသည့် နေရာ-၄ (SW-4) ၌ ရေနမူနာရယူခြင်းနှင့်တိုင်းတာခြင်း

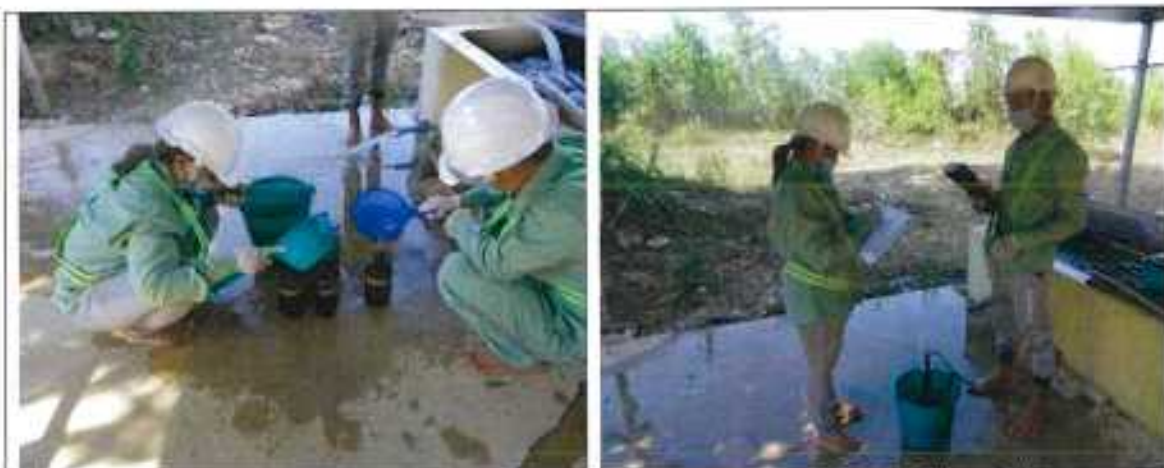
မြေအောက်ရေနမူနာယူသည့် နေရာ-၂ (GW-2) ရေနမူနာရယူခြင်းနှင့်တိုင်းတာခြင်း

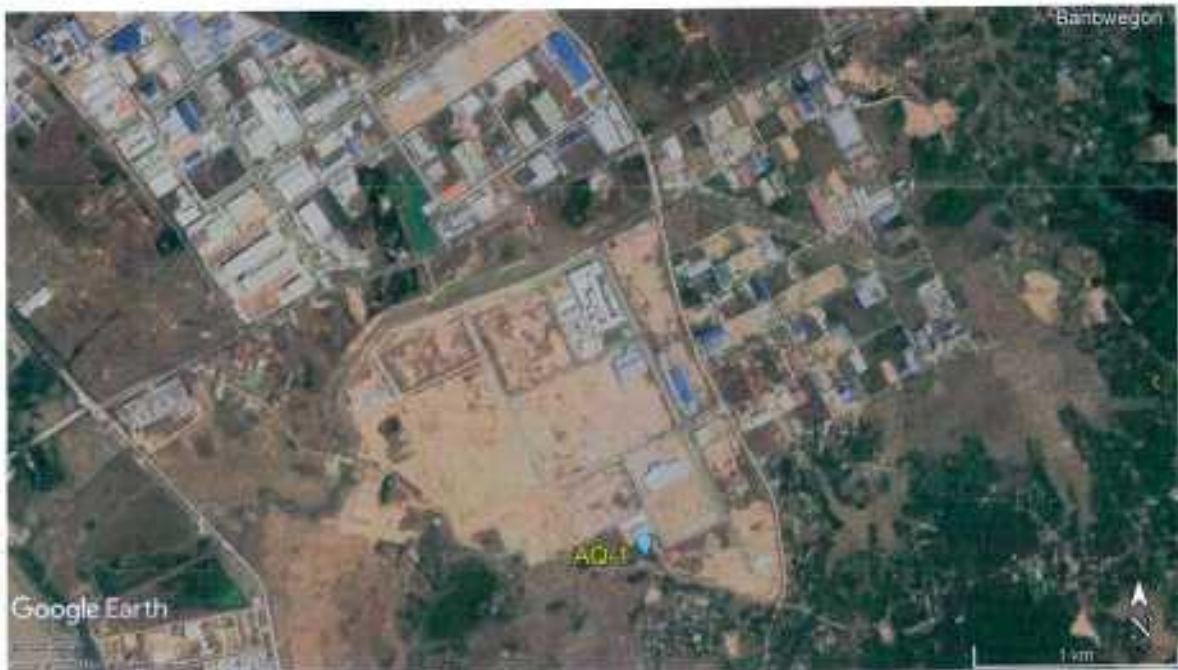
ပုံ၂.၂-၁ လေထုအရည်အသွေးစောင့်ကြည့်လေ့လာသည့်တည်နေရာ

ပတ်ဝန်းကျင်လေထုအရည်အသွေးတိုင်းတာသည့် စက်ကိရိယာဖြစ်သည့် "Haz-Scanner Environmental Perimeter Air Station (EPAS)" ဖြင့် သီလဝါအထူးစီးပွားရေးဇုန်၏ တောင်ဘက်၊ မြောက်လတ္တီတွဒ် ၁၆°၃၉'၂၄.၂၁"၊ အရှေ့လောင်ဂျီတွဒ် ၉၆°၁၇'၁၅.၈၀"၊ ဖလမ်းကျေးရွာ၊ ဖလမ်းရွာဦးကျောင်းဝန်းထဲတွင် တပ်ဆင်ထားပြီး တောင်ဘက်တွင် ဖလမ်းကျေးရွာရှိလူနေအိမ်များ၊ အနောက်ဘက်တွင် လယ်ကွင်းများ၊ မြောက်ဘက်တွင် သီလဝါအထူးစီးပွားရေးဇုန်အပိုင်း(က)၊ အရှေ့မြောက်ဘက်တွင် ပြည်တွင်းသီလဝါစက်မှုဇုန်နှင့် အရှေ့၊ မြောက်၊ မြောက်-အနောက်မြောက်၊ အနောက်မြောက် နှင့် အရှေ့မြောက်ဘက်တို့တွင် တည်ဆောက်ဆဲ သီလဝါအထူးစီးပွားရေးဇုန် အပိုင်း(ခ)တို့ဖြင့် ဝန်းရံထားသည်။ လေထုအရည်အသွေး စောင့်ကြည့်လေ့လာမှုကို ဖလမ်းကျေးရွာရှိ လူနေအိမ်များနှင့် အနီးဆုံးနေရာဖြစ်သော အထက်ပါနေရာ၌ ဆောင်ရွက်ခဲ့သည်။ အဓိကလေထုညစ်ညမ်းမှုကို ဖြစ်နိုင်သောစွန့်ထုတ်ဓာတ်ငွေ့များ ထုတ်လွှတ်ရာ အရင်းအမြစ်များမှာ ဆောက်လုပ်ရေးလုပ်ငန်းစဉ်များမှ ဖုန်များထွက်ရှိခြင်း၊ ဆောက်လုပ်ရေးလုပ်ငန်းသုံး ယာဉ်များနှင့် ဖလမ်းကျေးရွာရှိနေထိုင်သူများ၏ နေ့စဉ်လုပ်ငန်းဆောင်တာများကြောင့် ဖြစ်နိုင်ပါသည်။ လေထုအရည်အသွေး စောင့်ကြည့်လေ့လာသောနေရာကို ပုံ၂.၂-၁ တွင်ပြသထားပါသည်။

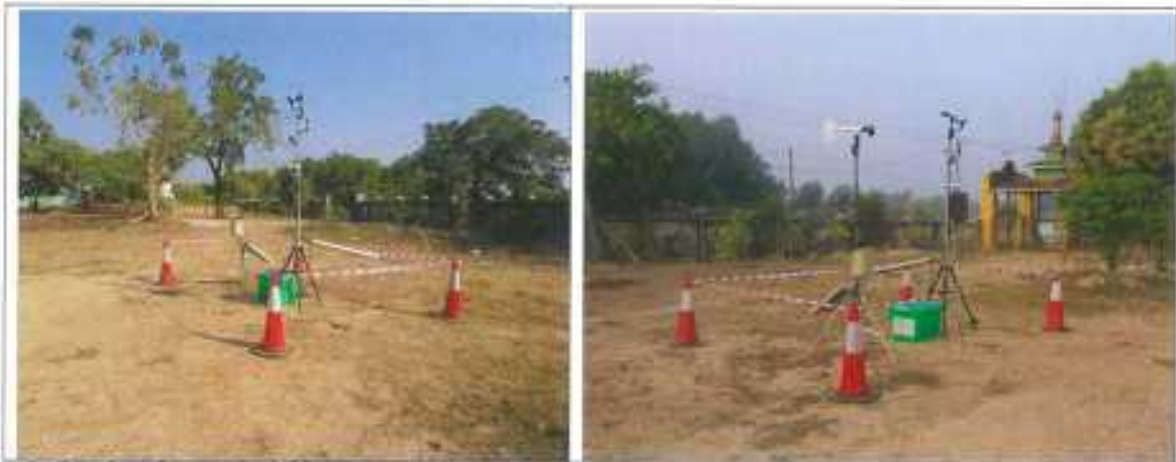
### ပုံ ၂.၄-၁ လေထုအရည်အသွေးစောင့်ကြည့်လေ့လာခြင်းအခြေအနေ

ပတ်ဝန်းကျင်လေထုအရည်အသွေး စံနမူနာယူခြင်းနှင့် ဆန်းစစ်လေ့လာခြင်းများကို အမေရိကန် ပတ်ဝန်းကျင်ဆိုင်ရာ ထိန်းသိမ်းရေးအေဂျင်စီ (U.S. EPA) ၏ အကြံပြုချက်များကို ကိုးကား၍ ကာဗွန်မိုနောက်ဆိုဒ် (CO)၊ နိုက်ထရိုဂျင်ဒိုင်အောက်ဆိုဒ် (NO<sub>2</sub>)၊ အမှုန်အမွှား (PM<sub>2.5</sub>)၊ အမှုန်အမွှား (PM<sub>10</sub>) နှင့် ဆာလဖာဒိုင်အောက်ဆိုဒ် (SO<sub>2</sub>)တို့အား စောင့်ကြည့်လေ့လာမှုများ လုပ်ဆောင်ခဲ့သည်။ ပတ်ဝန်းကျင်လေထုအရည်အသွေးကို စောင့်ကြည့်တိုင်းတာ၍ အချက်အလက်ရယူရန်အတွက် The Haz-Scanner Environmental Perimeter Air Station (EPAS)ကို အသုံးပြုခဲ့ပါသည်။ လေထုအရည်အသွေး အချက်အလက်များကို တစ်မိနစ်တိုင်း အလိုအလျောက်တိုင်းတာသည့် အရည်အသွေးအမျိုးအစား၏ အချက်အလက်များ (ကာဗွန်မိုနောက်ဆိုဒ် (CO)၊ နိုက်ထရိုဂျင်ဒိုင်အောက်ဆိုဒ် (NO<sub>2</sub>)၊ အမှုန်အမွှား (PM<sub>2.5</sub>)၊ အမှုန်အမွှား (PM<sub>10</sub>) နှင့် ဆာလဖာဒိုင်အောက်ဆိုဒ် (SO<sub>2</sub>)) ကို မှတ်တမ်းတင် သိမ်းဆည်းထားပါသည်။ လေထုအရည်အသွေး စောင့်ကြည့်လေ့လာသော အခြေအနေကို ပုံ၂.၄-၁တွင် ပြသထားပါသည်။

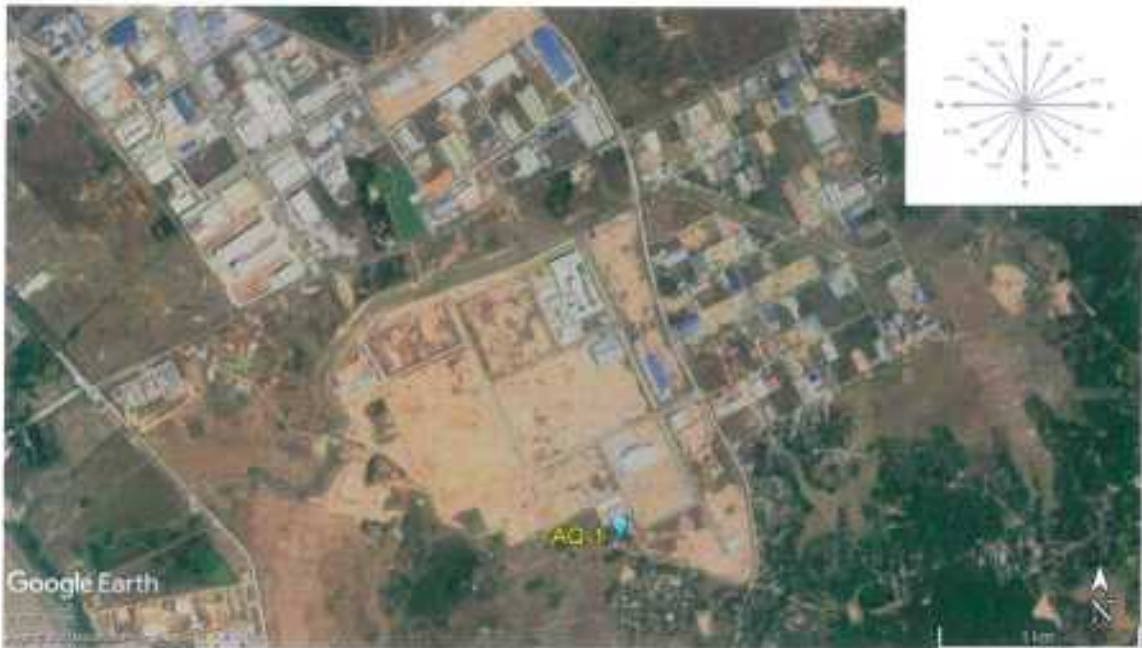
### ပုံ.၅-၁ လေထုအရည်အသွေးစောင့်ကြည့်လေ့လာသောတည်နေရာ နှင့် လေတိုက်ခတ်ရာအရပ်အခြေအနေ

လေထုအရည်အသွေးစောင့်ကြည့်လေ့လာသည့် နေရာ-၁ (AQ-1)တွင် လေတိုက်ခတ်ရာအရပ်နှင့် လေတိုက်နှုန်းကို တိုင်းတာခဲ့ပါသည်။ တိုင်းတာထားသော လေတိုက်ခတ်ရာအရပ်နှင့် လေတိုက်နှုန်းတို့၏ တစ်နာရီပျမ်းမျှ တန်ဖိုးများကို နောက်ဆက်တွဲ-၁ တွင်ဖော်ပြထားပါသည်။ လေထုအရည်အသွေး စောင့်ကြည့်လေ့လာသော တည်နေရာ၏ အခြေအနေနှင့် လေတိုက်ခတ်ရာအရပ်တို့အား ပုံ ၂.၅-၁ တွင် ပြသထားပါသည်။ လေတိုက်ခတ်ရာအရပ်ပေါ်မူတည်၍ အနောက်-အနောက်မြောက် (WNW)၊ အနောက်မြောက် (NW)၊ မြောက်-အနောက်မြောက် (NNW)၊ မြောက် (N)၊ မြောက်-အရှေ့မြောက် (NNE)၊ အရှေ့မြောက် (NE)၊ အရှေ့-အရှေ့မြောက် (ENE) နှင့် အရှေ့ (E) အရပ်တို့မှ တိုက်ခတ်သောလေမှာ ဇွန်အပိုင်း(ခ)၏ ဆောက်လုပ်ရေး လုပ်ငန်းခွင်မှ တိုက်ခတ်ကြောင်းခန့်မှန်းနိုင်ပါသည်။

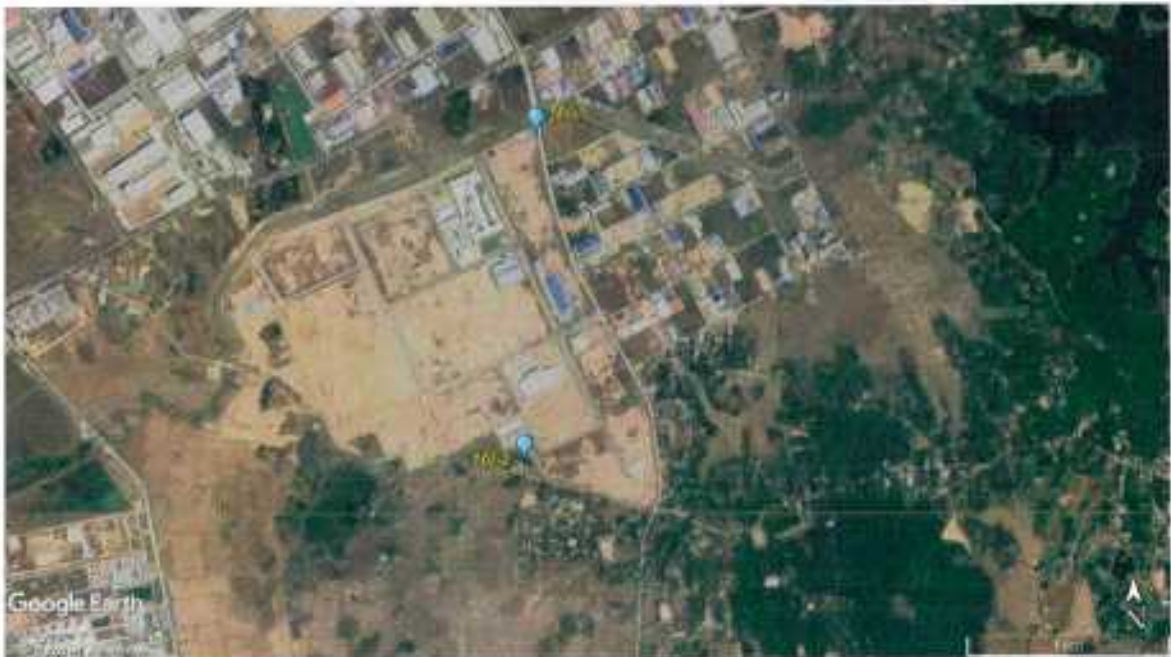
ပုံ ၂.၂-၁ ဆည်သံနှင့်တုန်ခါမှု စောင့်ကြည့်လေ့လာသည့်တည်နေရာများ

ယာဉ်သွားလာမှုကြောင့်ဖြစ်ပေါ်လာသော ဆည်သံနှင့်တုန်ခါမှုများကို အဓိကထားတိုင်းတာနိုင်ရန် သီလဝါအထူးစီးပွားရေးဇုန် အပိုင်း(ခ)၏ အရှေ့မြောက်ဘက်ထောင့် မြောက်လတ္တီတွဒ် ၁၆°၄၀'၁၈.၂၂"၊ အရှေ့လောင်ဂျီတွဒ် ၉၆°၁၇'၁၈.၁၈" တွင် စောင့်ကြည့်လေ့လာသည့် နေရာ-၁ (NV-1) နှင့် သီလဝါအထူးစီးပွားရေးဇုန် အပိုင်း(ခ)၏ တောင်ဘက် ဖလမ်းကျေးရွာ၊ ဖလမ်းရွာဦးကျောင်းတိုက်အတွင်း မြောက်လတ္တီတွဒ် ၁၆°၃၉'၂၄.၉၀" ၊ အရှေ့လောင်ဂျီတွဒ် ၉၆°၁၇'၁၆.၇၀" တွင် စောင့်ကြည့်လေ့လာသည့် နေရာ-၂ (NV-2)ဟူ၍ ဆည်သံနှင့်တုန်ခါမှုအဆင့်များကို နှစ်နေရာ တိုင်းတာခဲ့ပါသည်။ ဆည်သံနှင့်တုန်ခါမှု စောင့်ကြည့် လေ့လာခဲ့သည့် တည်နေရာများကို ပုံ ၂.၂-၁ တွင် ပြသထားပါသည်။

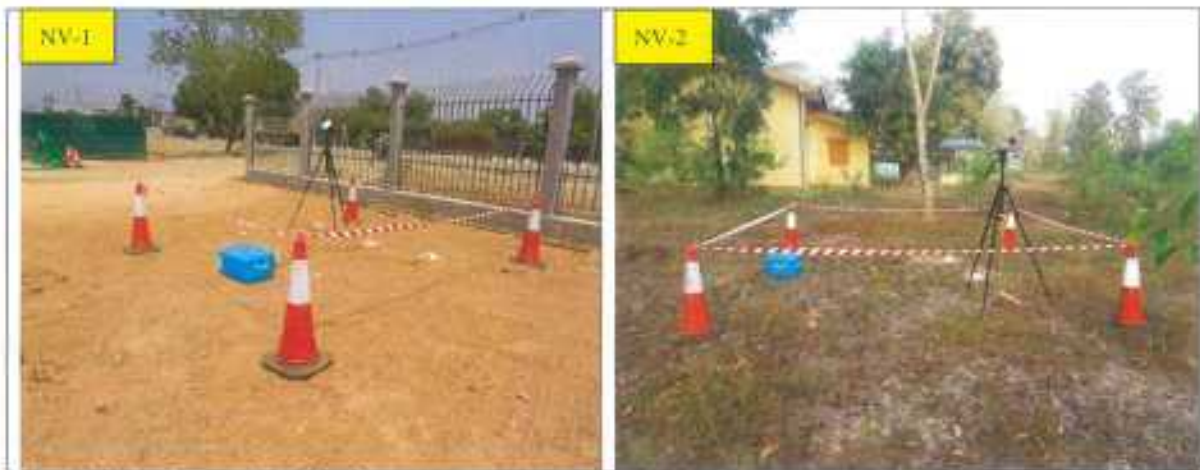
ပုံ ၂.၃-၁ ဆူညံသံနှင့်တုန်ခါမှုအဆင့် စောင့်ကြည့်လေ့လာမှုအခြေအနေ

ဆူညံသံအဆင့်အား "Rion NL-42 အသံအဆင့်တိုင်းတာသည့်ကိရိယာ" ဖြင့်တိုင်းတာပြီး ၁၀မိနစ်တိုင်း အလိုအလျောက်တိုင်းတာပြီး စက်အတွင်းရှိ မန်မိုရီကဒ်အတွင်း မှတ်သားထားပါသည်။ တုန်ခါမှုအဆင့် တိုင်းတာသည့် ကိရိယာ "Rion VM-53A" ဝင်ရိုးသုံးခုပါဝင်သော တုန်ခါမှုအဆင့် သတ်မှတ်သည့် ကိရိယာအား မြေကြီးပေါ်တွင် ထားရှိပါသည်။ တုန်ခါမှု (L<sub>a</sub>)အား နေရာ-၁ (NV-1)နှင့် နေရာ-၂ (NV-2)တို့၌ အလိုက်အသင့် ပြောင်းလဲနိုင်သောအဆင့် (၁၀-၇၀) dB အတွင်းထားရှိပြီး ၁၀ မိနစ်တိုင်း အလိုအလျောက် တိုင်းတာပြီး စက်အတွင်းရှိ မန်မိုရီကဒ်အတွင်း မှတ်သားထားပါသည်။

စောင့်ကြည့်လေ့လာသော နေရာတစ်ခုစီတွင် ဆူညံသံနှင့်တုန်ခါမှု စောင့်ကြည့်လေ့လာမှုအား ၂၄ နာရီ တိုင်းတာပါသည်။ နေရာ-၁ (NV-1) နှင့် နေရာ-၂ (NV-2) ရှိ ဆူညံသံနှင့်တုန်ခါမှုအဆင့် စောင့်ကြည့် လေ့လာသောအခြေအနေကို ပုံ ၂.၃-၁ တွင် ပြသထားပါသည်။

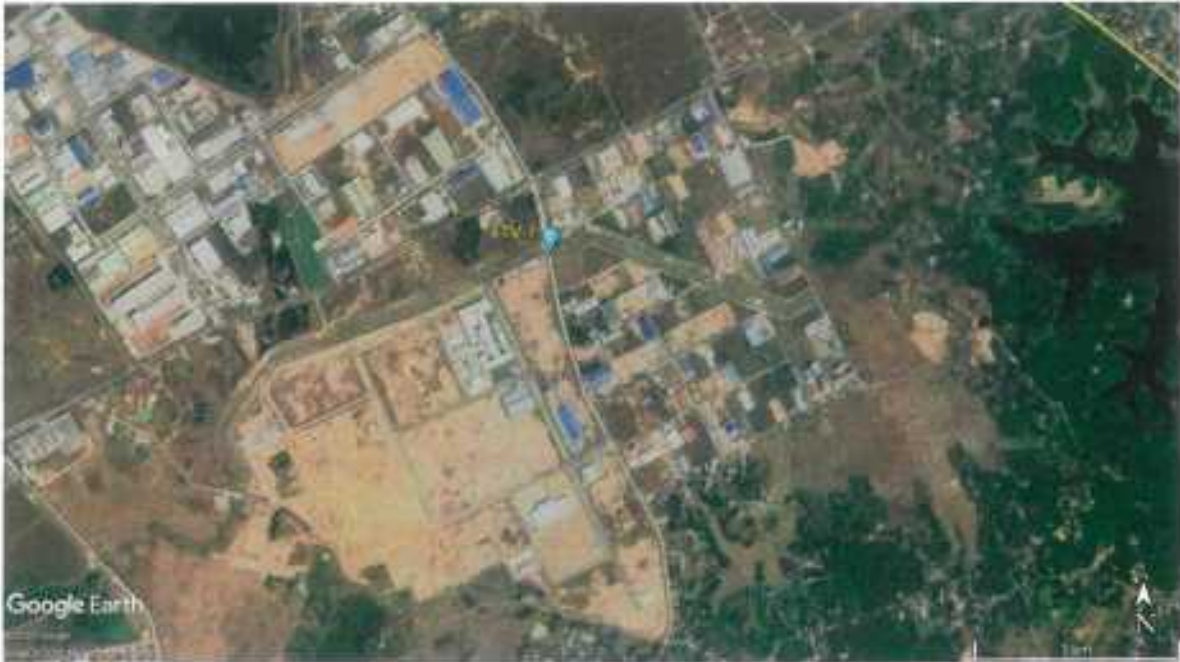
ပုံ ၂.၂-၁ ယာဉ်သွားလာမှုနှုန်း စောင့်ကြည့်လေ့လာသည့်တည်နေရာ

ယာဉ်သွားလာမှုနှုန်းအား သီလဝါအထူးစီးပွားရေးဇုန် အပိုင်း(ခ)၏ အရှေ့မြောက်ဘက်ထောင့်၊ မြောက်လတ္တီတွဒ် ၁၆°၄၈'၁၇.၉၀" ၊ အရှေ့လောင်ဂျီတွဒ် ၉၆°၁၇'၁၈.၂၀"နေရာ၌ စောင့်ကြည့်လေ့လာခဲ့ပါသည်။ ယာဉ်သွားလာမှုနှုန်း စောင့်ကြည့်လေ့လာသော တည်နေရာကို ပုံ ၂.၂-၁ တွင် ပြသထားပါသည်။

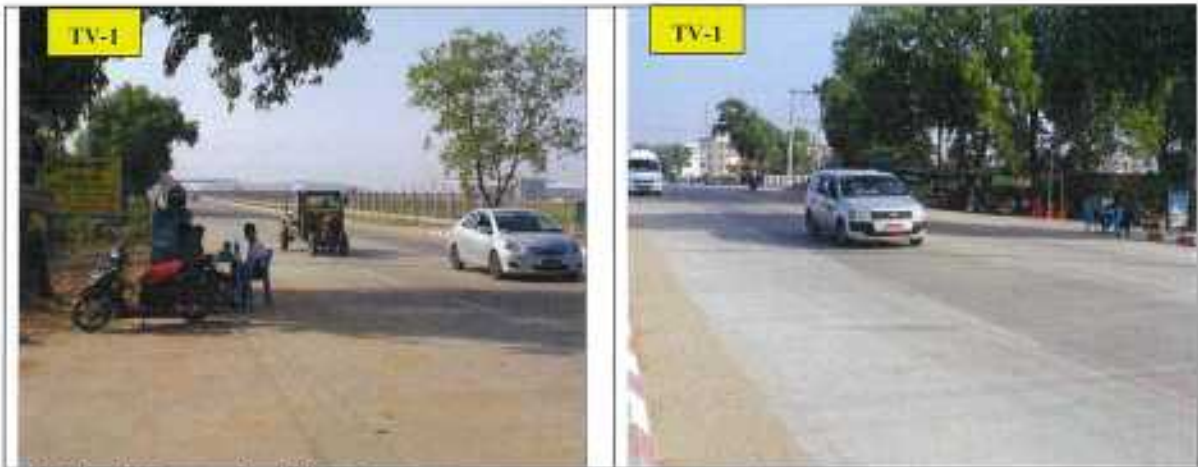
ပုံ ၂.၃-၁ နေရာ-၁ (TV-1) ၌ယာဉ်သွားလာမှုနှုန်း စောင့်ကြည့်လေ့လာခြင်းအခြေအနေ

ယာဉ်သွားလာမှုနှုန်း စောင့်ကြည့်လေ့လာခြင်း ဆောင်ရွက်နေစဉ်တွင် ယာဉ်သွားလာမှုကြောင့် ဖြစ်ပေါ်နိုင်သော ဆူညံသံနှင့်တုန်ခါမှုတိုင်းတာခြင်းကိုပါ တစ်ပြိုင်နက်တည်း ၂၄ နာရီကြာ ဆောင်ရွက်ခဲ့ပါသည်။ ယာဉ်သွားလာမှုနှုန်း စောင့်ကြည့်လေ့လာမှုကို ဖလမ်းကျေးရွာမှ ဒဂုံ-သီလဝါလမ်းသို့ လာသော ယာဉ်အရေအတွက်နှင့် ဒဂုံ-သီလဝါလမ်းမှ ဖလမ်းကျေးရွာသို့ လာသောယာဉ်အရေအတွက် အသီးသီးကို ရေတွက်ခဲ့ပါသည်။ ယာဉ်အရေအတွက်ကို လူကိုယ်တိုင် တိုက်ရိုက်စောင့်ကြည့်၍ တာလီချိုးမှတ်သားခြင်းဖြင့် မှတ်သားခဲ့ပါသည်။ နေရာ-၁ (TV-1)၌ ယာဉ်သွားလာမှုနှုန်း စောင့်ကြည့်လေ့လာခြင်း အခြေအနေကို ပုံ ၂.၃-၁ တွင် ပြသထားသည်။
